Transportation Services Department

Hunt Club Road & Riverside Drive In-Service Road Safety Review

April 20, 2020

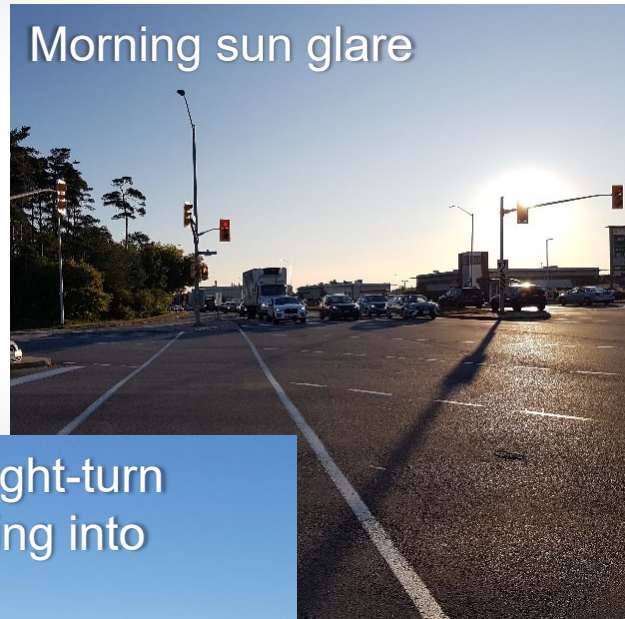
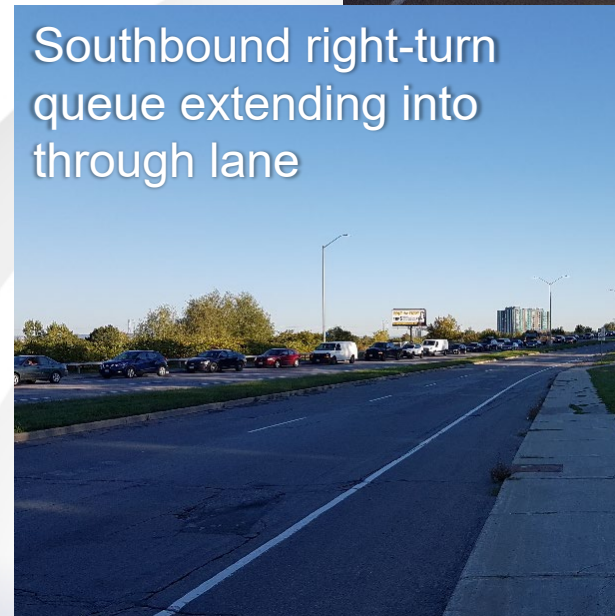
Southbound Right-Turn

- The following were noted as possible contributing factors to issues experienced at this location:
 - Sun glare
 - Sharp angle for checking for approaching vehicles
 - Driver's need to check for both westbound through and northbound left vehicles
 - Queue spills into through lane

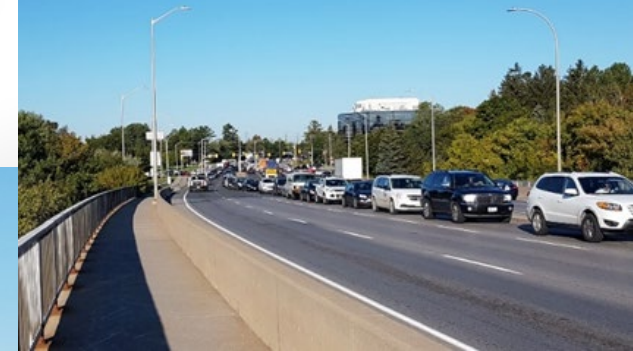
- The eastbound left-turn queue in the morning extended up to and beyond Prince of Wales Drive.
- Several driver's were observed illegally using the northbound right-turn lane into Hunt Club Marketplace to by-pass the queue and turn right onto Hunt Club Road.

Eastbound left queue spills back into eastbound through lane

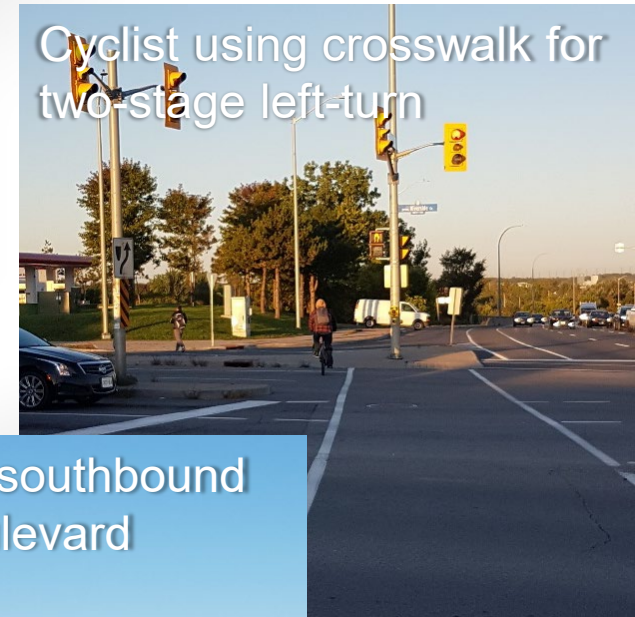
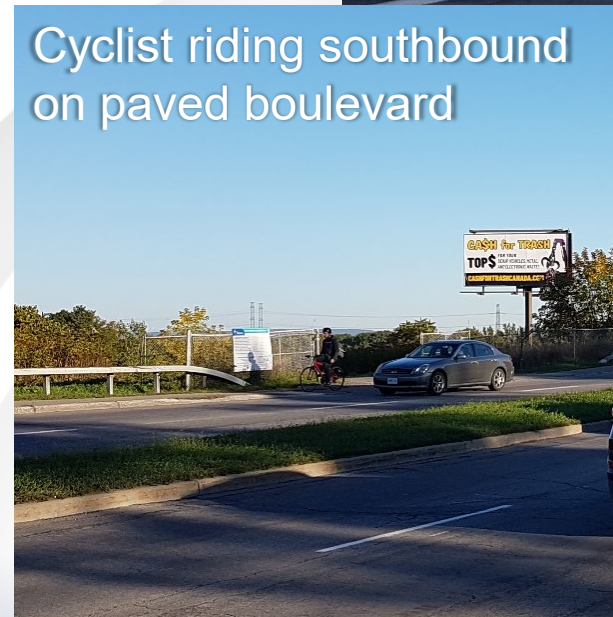
Cyclists Issues

- It was observed that:
 - Cyclists prefer using the crosswalks to turn left rather than use the left-turn bike lanes provided; and
 - Some preferred riding on the paved boulevard north of Hunt Club Road rather than on the road with general traffic.
