RE: Riverwood Park Trees

The purpose of this memo is to provide a summary of the observations and assessments made by CBCL during the July 26, 2024, field investigation under pre-construction conditions.

Project No: 243606.00

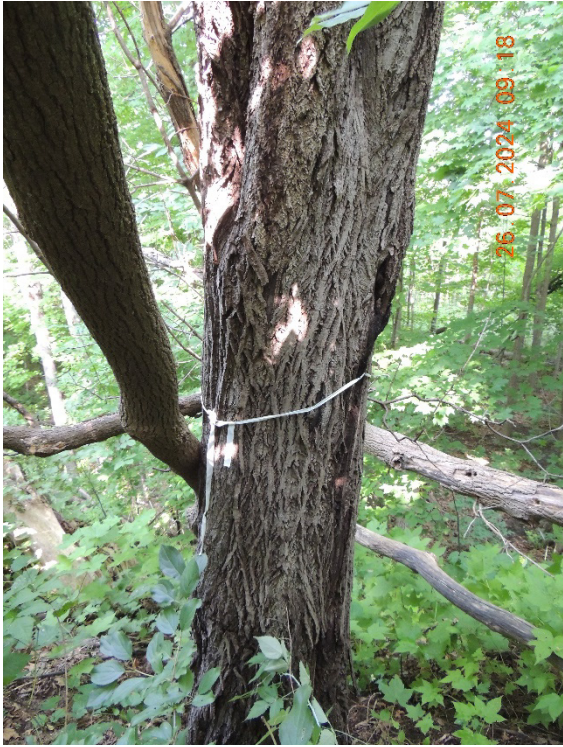
Butternut 001 is a large specimen situated on the edge of a forested slope within Riverwood Park along an existing cut pathway. The specimen is a large, healthy individual with vigorous crown growth. Most dieback of twigs and branches were localized to shaded limbs with very little of the crown that was observed to be dead (approximately 85% live crown). Due to the large size of the tree and the timing of the assessment (after flowering and fruiting), examination of traits for hybridism were limited and a conclusion was not able to be determined. However, no signs of hybridism were apparent during the assessment except for the vigorous, healthy live crown. Large cankers caused by the Butternut Canker (*Ophiognomonia clavignenti-juglandacearum*) fungus were observed within the first 2 metres (m) of the trunk; however, very few cankers were observed above this point. The BHA calculated this individual to be a Category 2. Based on the definitions in Ontario Regulation (O. Reg.) 830/21: Exemptions – Barn Swallow, Bobolink, Eastern Meadowlark and Butternut under the *Endangered Species Act, 2007*, Category 2 Butternuts are “... *not affected by Butternut Canker or the Butternut tree is affected by Butternut Canker but the degree to which it is affected is not as advanced as a Category 1 Butternut tree and retaining the tree could support the protection or recovery of Butternut trees in the area in which the tree is located.*”

Very large, healthy individual on the edge of a forested slope with no root flare. Some large cankers are present below the crown, but very minimal above. Wide spreading, vigorous crown with most of the twig/branch dieback due to shading. Some insect damage to leaves. Branches are too high to closely examine hybrid traits.

Photo 1: Butternut 001 trunk

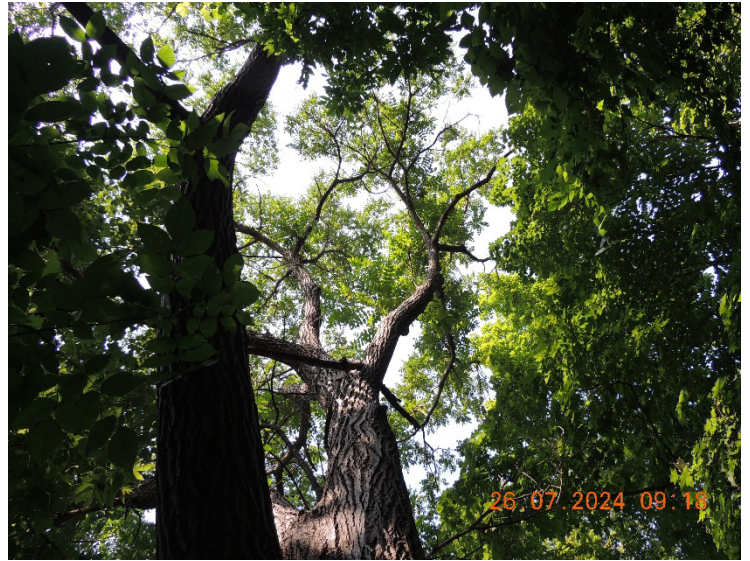
Photo 2: Butternut 001 live crown

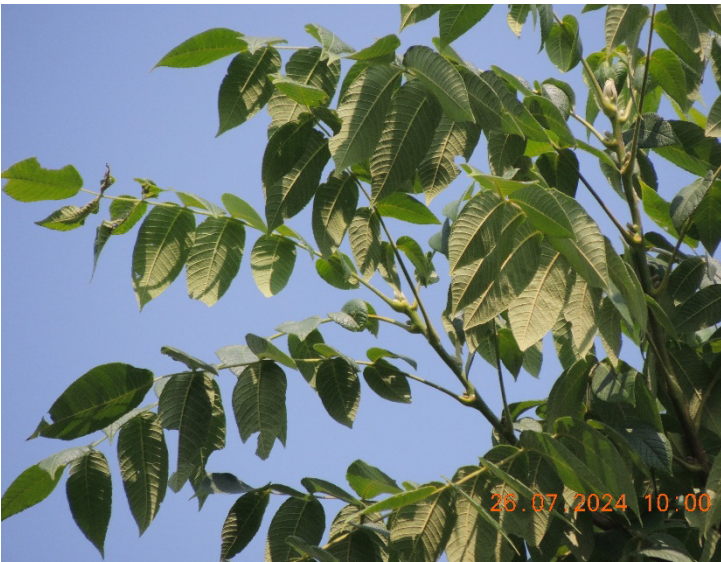
Photo 3: Butternut 001 leaves and twig

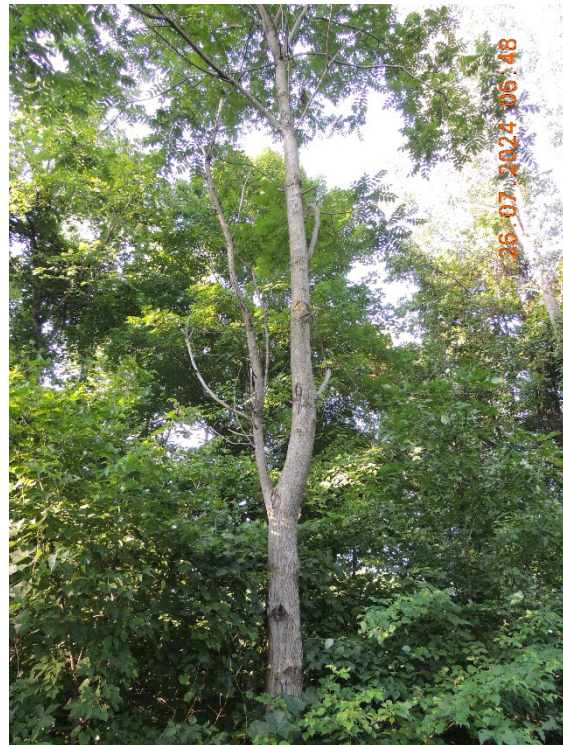
Butternut 002 is a tall specimen situated on the edge of pathway within the forested area of Riverwood Park. The specimen is approximately 25 m tall and healthy with vigorous crown growth. Dieback of twigs and branches were localized to shaded limbs as no dead crown was observed (100% live crown). Due to the tall height of the tree and the timing of the assessment (after flowering and fruiting), examination of traits for hybridism were limited and a conclusion was not able to be determined. However, the only signs of hybridism that were apparent during the assessment was the pinkish colour of the fissures in the bark and vigorous, healthy live crown. Abundant cankers caused by the Butternut Canker fungus were observed in the root flare and within the first 2 m of the trunk. Few cankers were observed above 2 m of the trunk. The BHA calculated this individual to be a Category 1. Based on the definitions in O. Reg. 830/21: Exemptions – Barn Swallow, Bobolink, Eastern Meadowlark and Butternut under the *Endangered Species Act, 2007*, Category 1 Butternuts are “... *affected by Butternut Canker to such an advanced degree that retaining the tree would not support the protection or recovery of Butternut trees in the area in which the tree is located.*”

Photo 4: Butternut 002

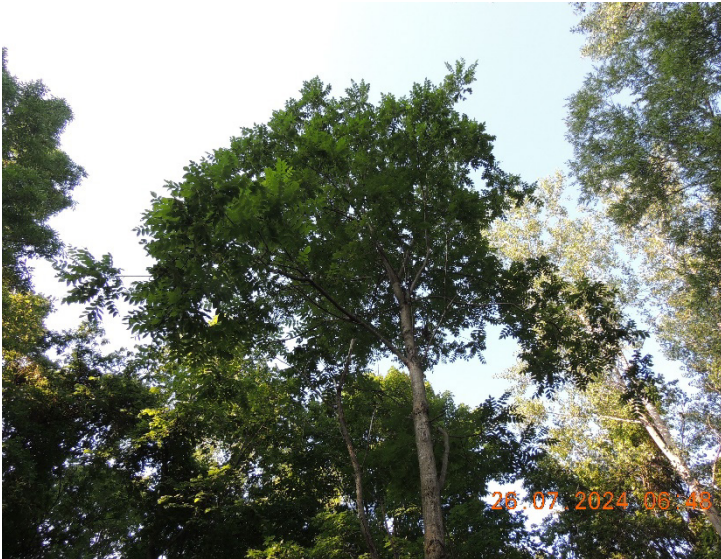
Photo 5: Butternut 002 live crown

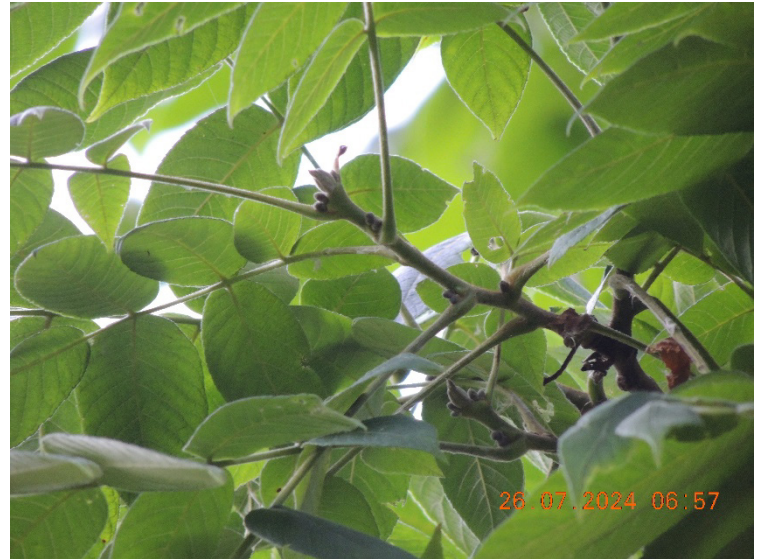
Photo 6: Butternut 002 leaves and twig

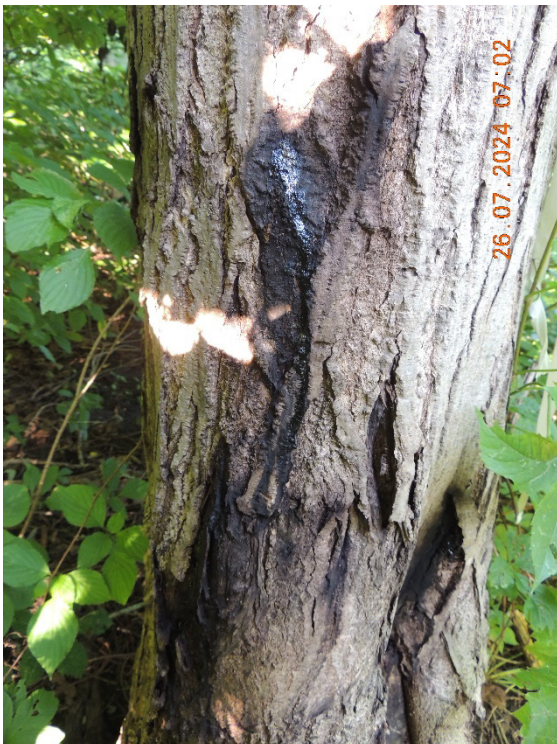
Very vigorous with very healthy live crown, some insect damage to leaves. All twig/branch dieback is due to shading and very minimal. Branches are too high to closely examine hybrid traits. High concentrations of cankers on root flare and first 2 m of stem, then very minimal above.

Photo 7: Butternut 002 cankers on trunk

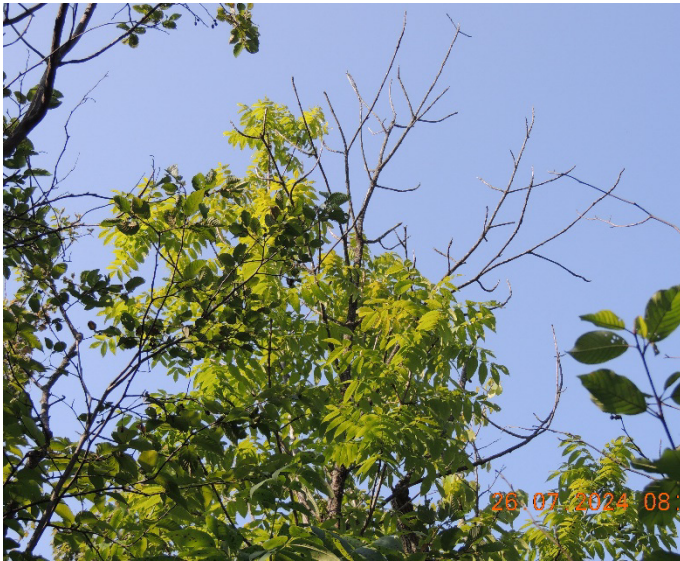
compound leaves with sessile leaflets, dark brown to chocolate-coloured buds, and large, rounded leaf scars. The majority of these individuals appeared healthy and were too small to be impacted by the invasive Emerald Ash Borer (EAB) (*Agilus planipennis*); however, some individuals did exhibit crown dieback that may have been the result of EAB damage. Other ash species such as White Ash (*Fraxinus americana*) were observed growing among the Black Ash within the swamp. Any Black Ash that is healthy and 8 cm DBH or higher as defined under O. Reg. 6/24 of the *Endangered Species Act, 2007* is afforded protection. The habitat protection provisions under O. Reg. 832/21 of the ESA would apply to an area of 30 m around each of the individuals that meet the above criteria.

Photo 21: Black Ash dead crown with live branches below

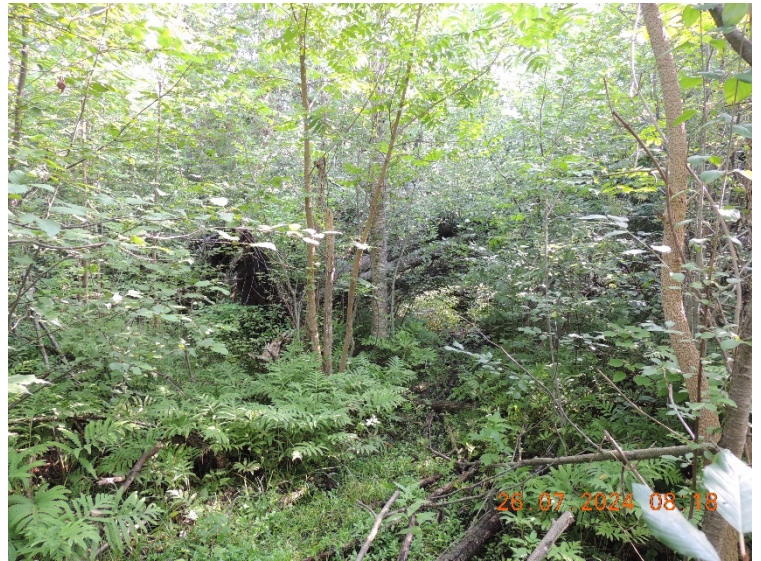
A low-lying swamp situated west of the existing pathway and directly adjacent to the Rideau River was traversed to record observations of Black Ash. A total of 60 Black Ashes were recorded within this area. The majority of these individuals were saplings and very few approached 8 cm DBH. These individuals were characterized by light brown to tan coloured bark with soft, corky ridges,

Photo 22: Black Ash swamp habitat

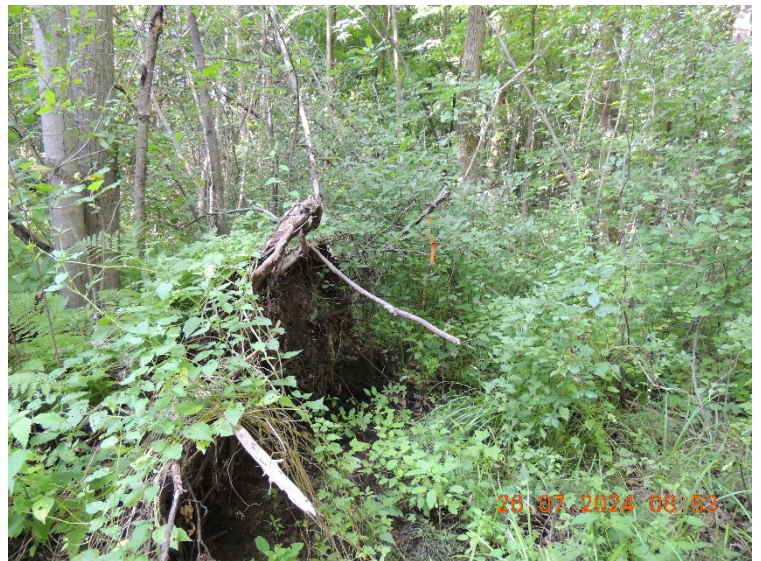
An alternate pathway in Riverwood Park was marked by orange flagging tape. This pathway was traversed to determine conditions of the area. The large Yellow Birch individual mentioned above was situated within this alternate pathway. The pathway was situated in a sloped forested area with moist to wet soil dominated by deciduous trees such as Yellow Birch, Basswood (*Tilia americana*), and Sugar Maple (*Acer saccharum*). Some areas of the forest were open with little ground cover while others contained abundant native ground cover. At least three natural flowing drainages (not fish habitat) crossed the alternate pathway which is where the soils became wet and the ground cover was abundant. The alternate pathway ended at the existing cut pathway within the forest. Several Sugar Maples, Basswoods, White Ashes, and Yellow Birches were noted within the general alternate pathway which would be subject to protection under the City of Ottawa's Tree Protection By-Law (2020-340). The northern half of the alternate pathway is situated within an Urban Natural Area as defined on Schedule C-11 of the City of Ottawa's *Official Plan* (2021). A permit to exempt protection of any trees in the Urban Natural Area must be obtained if injury is to occur to trees or their critical root zones (CRZ). Additionally, no plants are to be injured or destroyed within the Urban Natural Area without a permit. The southern half of the alternate pathway is situated on private property that is greater than 1 ha in size. Therefore, under By-Law 2020-340, any tree that is 10 cm DBH or greater, is afforded protection from harm unless a permit to exempt the protection of those tree is obtained.

Photo 24: Alternate pathway thick growth area associated with drainage areas
