Transportation Services Department

Hunt Club Road & Riverside Drive In-Service Road Safety Review

April 20, 2020

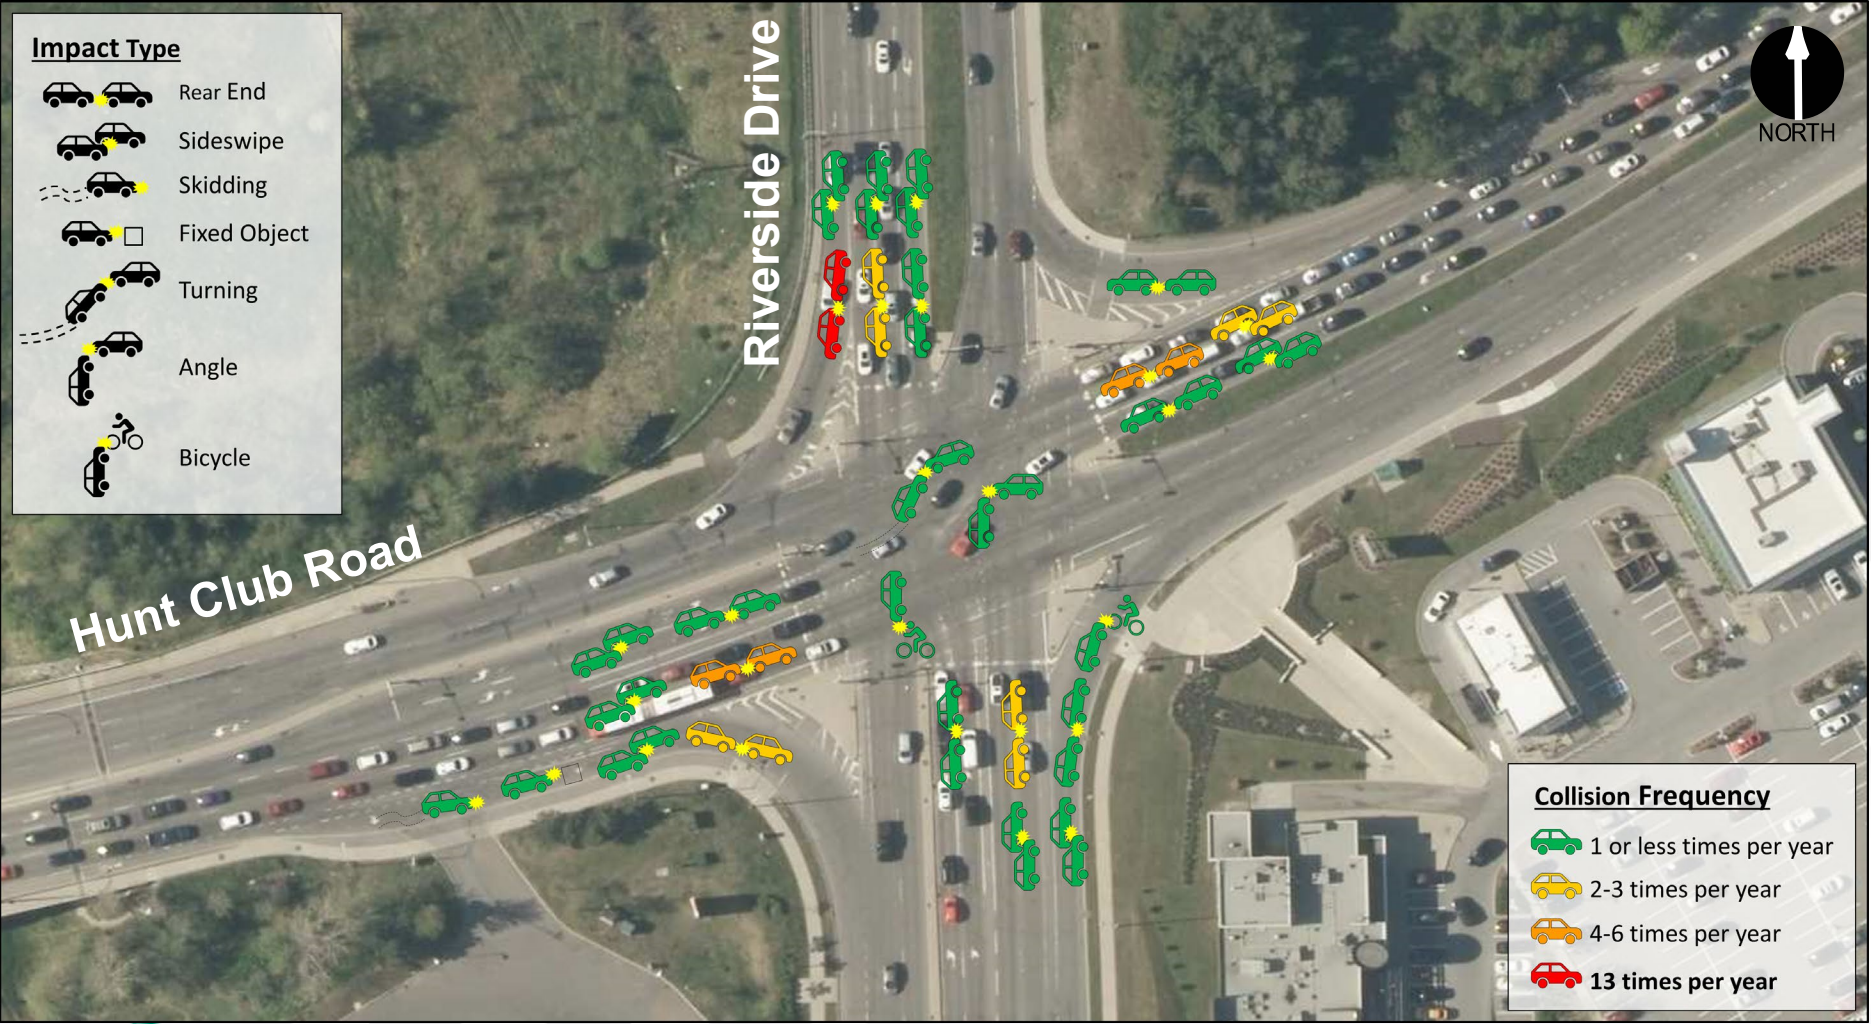
Collision Diagram: Frequency and Location of Recorded Collisions, 2008-2018

Collision Diagram (continued)

- As the collision diagram illustrates, rear-end collisions in the southbound right-turn, eastbound through and westbound through lanes were the most frequent.
- Rear-end collisions in the northbound through, southbound through and eastbound right-turn lanes as well as sideswipe collisions in the westbound through lanes occurred on average 2-3 times per year.
- Most other impact-type/direction combinations occurred less than once per year on average.
